**Technical Service  
BULLETIN**

**REPAIR MANUAL SUPPLEMENT:  
VEHICLE PULLING TO ONE SIDE**

**All '02 – '07 Toyota & '04 – '07 Scion Models**

**STEERING**  
**ST005-01**  
**REVISED**

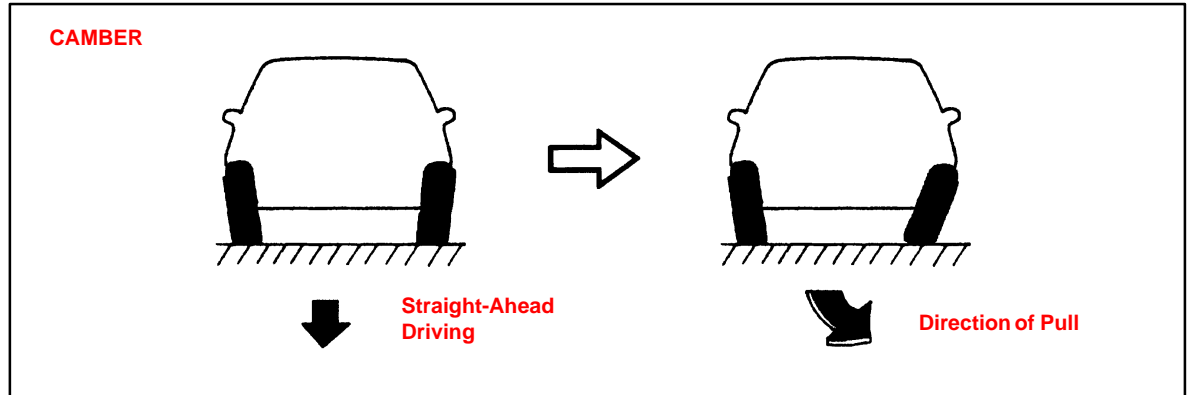
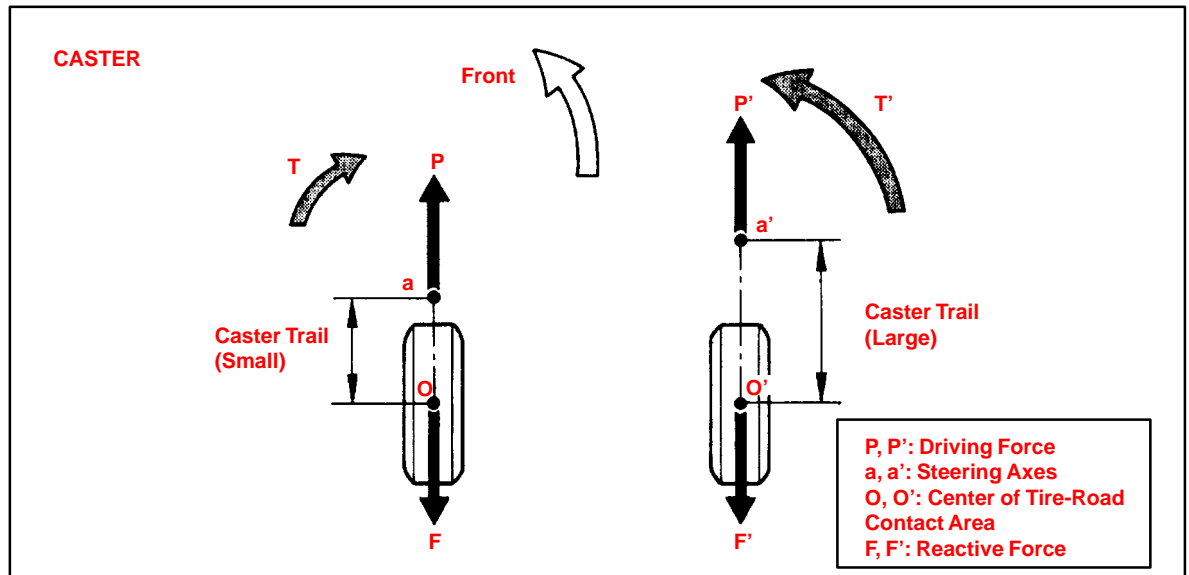
When the cross camber or caster of the front wheel alignment is large, it can cause vehicle pulling.

WHEEL ALIGNMENT	DIRECTION OF VEHICLE PULLING
Camber	Vehicle pulls in direction of wheel with large camber value
Caster	Vehicle pulls in direction of wheel with small caster value

If the cross camber or caster is within the specified range (30' or less), noticeable vehicle pulling will not occur due to side-to-side differences in camber or caster.

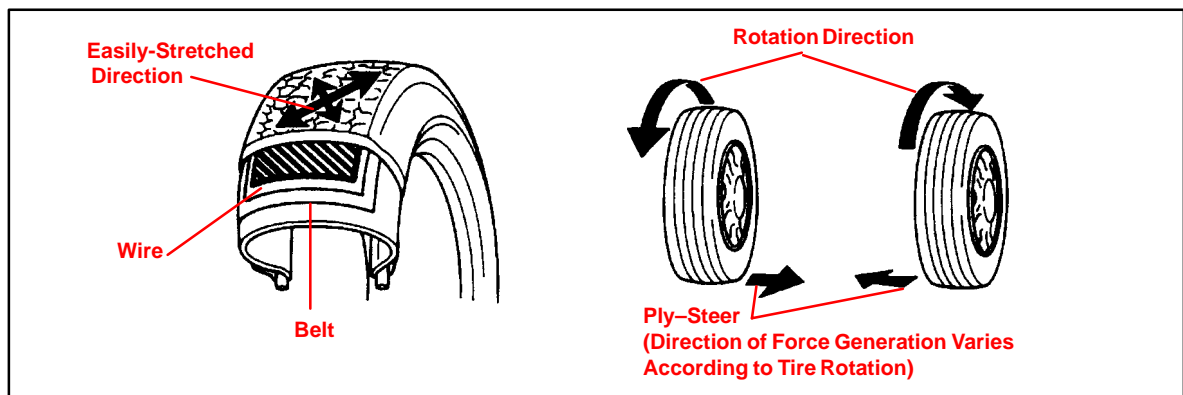
Lateral force due to ply-steer is produced by the construction of the belts inside the tire tread. With radial tires, the wire of the belt is slanted as shown in the illustration below. Thus, it is in the lateral direction that tire tread easily changes shape (stretches), and lateral force is generated between the tire and the road surface in the lateral direction.

Lateral force from ply-steer prevents vehicle drift caused by road slant, so in many cases lateral force to the left is provided to compensate for road slant to the right.

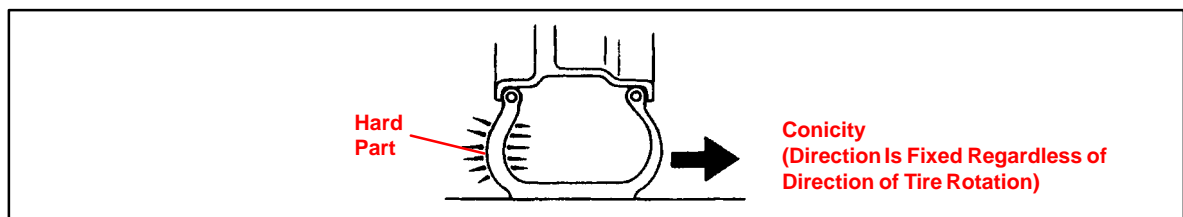
Conicity is lateral force resulting from uneven formation of the left and right sides of the tire. The direction the lateral force is exerted depends on the hardness of the side walls and the difference in height between the left/right sides of the tire.

- In the case of vehicle pulling caused by tires, the lateral force which is exerted as a result of conicity has the greatest effect. On a flat road, if the steering wheel is held without exerting steering effort for 100 m (109 yards) when travelling at 100 km/h (62 mph), the vehicle may drift as much as 1.5 m (5 ft).
- When vehicle pulling is due to conicity, the amount of drift can be reduced and the direction of drift can be changed by changing the location of the tire or reversing the tire when installing it on the wheel.

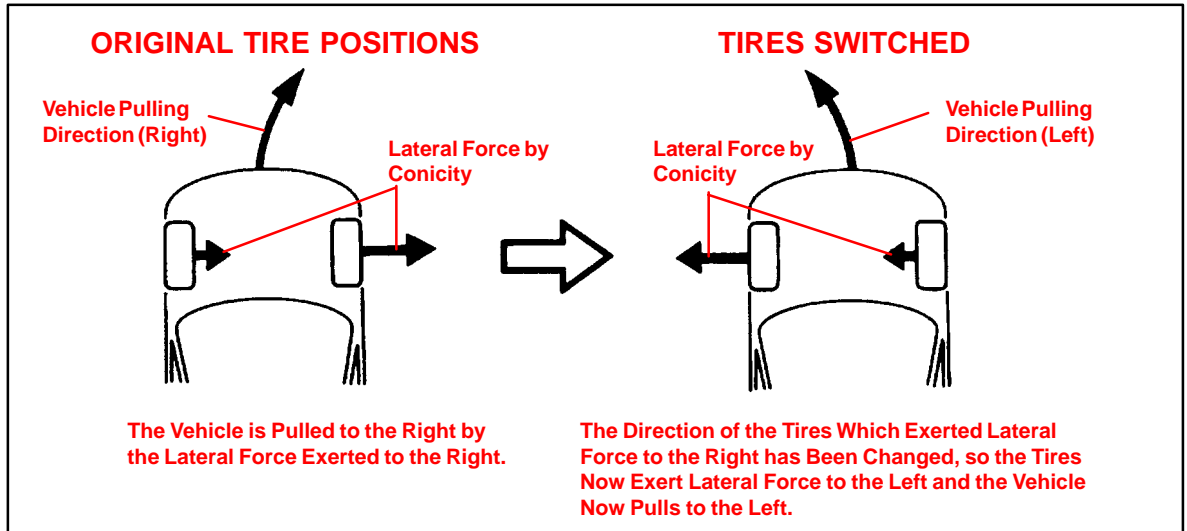
- The direction of lateral force from tire conicity becomes reversed when the left and right tires are switched. Therefore, if the pulling direction changes when the tires are switched, it can be concluded that vehicle pulling is caused by tire conicity.

- If the pulling direction does not change after the front tires are switched, the cause of vehicle pulling is not tire conicity. In this case, the likely cause is a front wheel alignment condition.

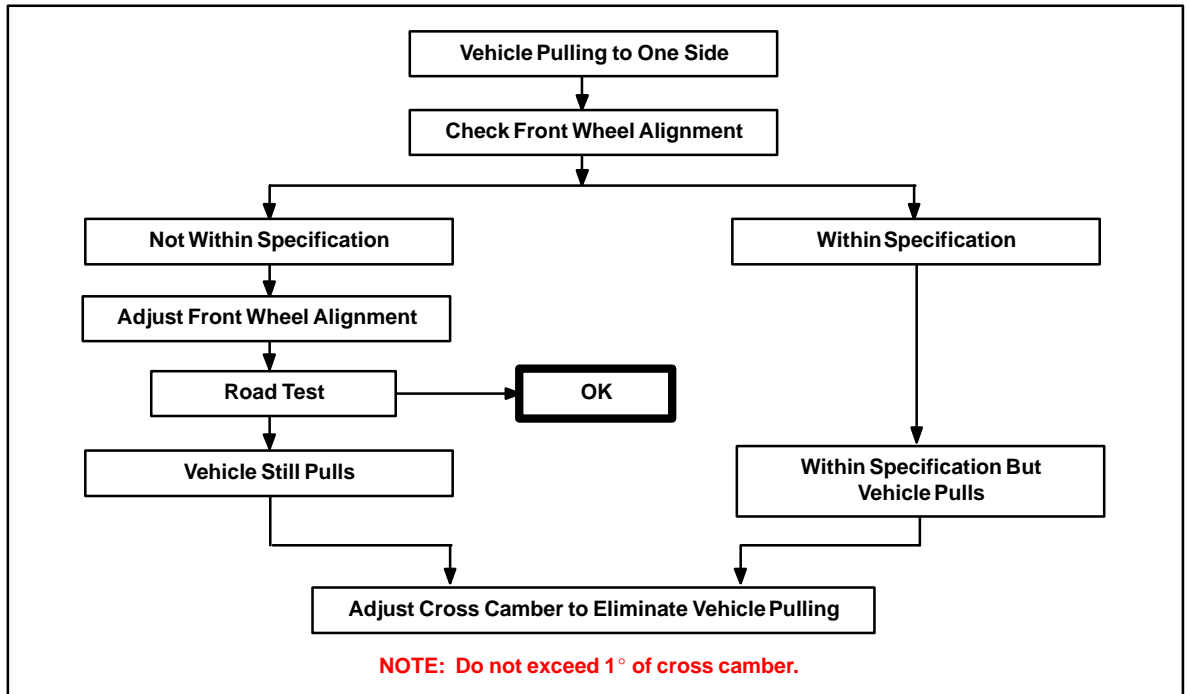
When it is determined by troubleshooting that the vehicle pulling to one side is caused by wheel alignment, perform repairs according to the following procedure.

WHEN VEHICLE PULLS TO LEFT	WHEN VEHICLE PULLS TO RIGHT
Increase right front camber and decrease left front camber until vehicle pulling is eliminated	Increase left front camber and decrease right front camber until vehicle pulling is eliminated

- Keep the cross camber within 1° or less.
- Keep the camber of each wheel within specifications (+/-45' of center value).
- If adjustment exceeds the specifications, uneven tire wear will result.

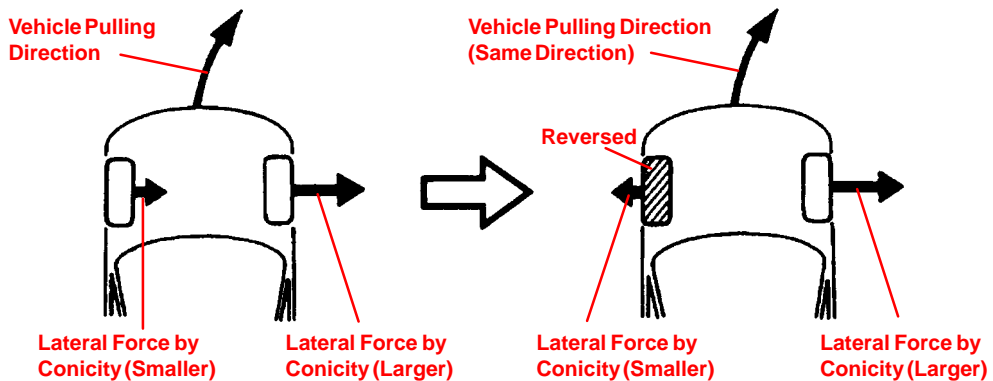
**If Vehicle Pulls in the Same Direction: Go to STEP 2.**

The lateral force generated by the right front tire is greater than the left tire, so the vehicle is pulling due to the lateral force of the right tire.

Remove the front left tire from the wheel and reverse the tire. Then perform a road test and check for change in the pulling direction.

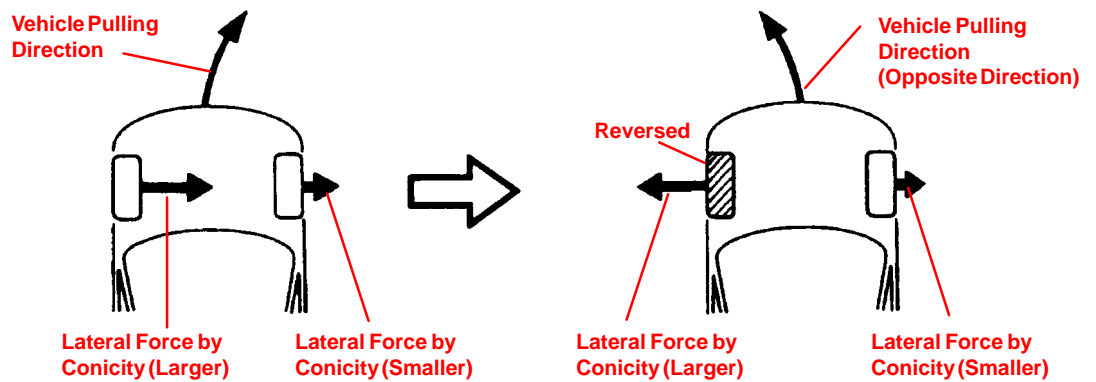
**If Vehicle Pulls in the Opposite Direction: Go to STEP 2.**

The lateral force generated by the left front tire is greater than the right tire, so the vehicle is pulling due to the lateral force of the left tire.
